Product Advisory

PA-662

TO:Owners, Users, Dealers, and InstallersModels Affected:XT52, XT55, XT58, XT60, XT60/70, XTPro56, XTPro60, XTPro60/70

SUBJECT: Leveling rod interference

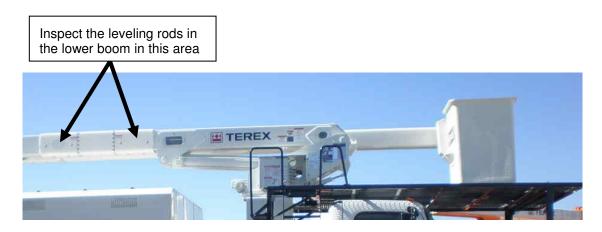
Some XT and XT Pro units (with extended life #80 leveling chain) could experience fiberglass insert bolt interference with a leveling rod due to leveling rod moving vertically during road travel. The leveling system must be inspected for wear or damage on the leveling rod. Wear on the leveling rod must be evaluated as instructed in the maintenance manual. **Excessive wear on a leveling rod may reduce the service life of the leveling rod.**

1. Inspect the leveling rods in the lower boom in the area shown below.

- 2. If contact is evident between the leveling rod and fiberglass insert bolt, turn bolt around so the head of the bolt is on the inside of the boom. Torque as stated in the manual.
- 3. If wear exceeds allowable as stated in the maintenance manual, order the appropriate leveling rod part number identified in the parts section of your manual for your units.
- 4. Terex Utilities recommends that you perform this action within 90 days of receipt of this bulletin or as stated in the Frequent and Periodic inspection interval shown in the manuals.
- 5. Always follow all inspection and maintenance requirements as specified in the manuals, including leveling system tension.
