Terex Utilities**PRODUCT ADVISORY****PA688****DATE:** 3/1/2021**REVISED:****TO:** Owners, Users, Dealers, and Installers**MODELS AFFECTED:** Terex Aerial Devices & Digger Derricks on Freightliner Chassis**SUBJECT:** Freightliner Chassis with Tri-Axle Rear Air Suspension**Issue:**

**Subject: Hendrickson Primaax EX 69,000 lb
Tri-Axle Rear Air Suspension Height-Control
Valve Relocation**

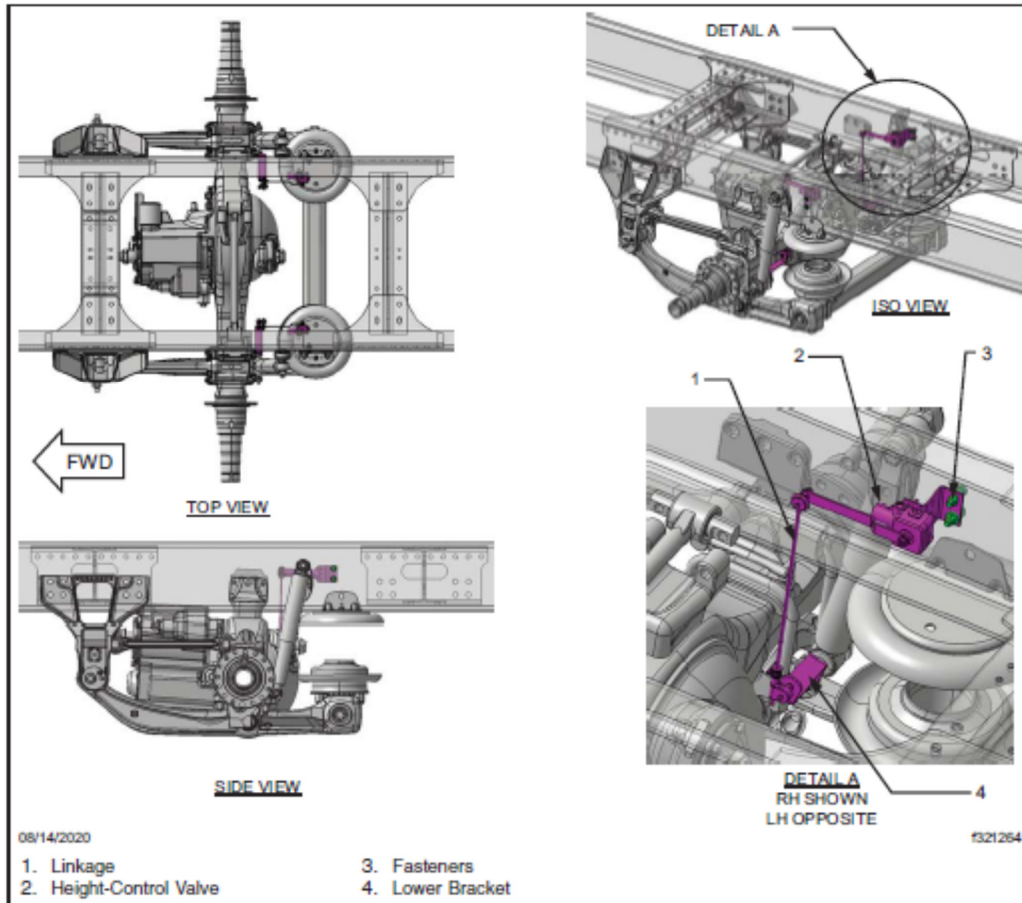
Fig. 1, Location of Height-Control Valves

The attached document provides work instructions for relocating the height-control valve downward 1.62 inches (41.3 mm) to prevent the linkage from protruding above the top flange of the frame when the suspension air is dumped.

1. Park the vehicle on a level surface, set the parking brakes, and *chock the tires*.
2. Put the transmission in neutral and build the air pressure to at least 100 psi. Shut down the engine.
3. Release the parking brakes.
4. Locate the height-control valves installed just rear of the mid-axle inside the left-hand and right-hand frame. See [Fig. 1](#).
