<b>Terex Utilities</b>	
<b>PRODUCT ADVISORY</b>	<b>PA705</b>

**SUBJECT:** 2017 – 2020 Model Year Ford F550 Frame Reinforcement

**SUBJECT: Customer Satisfaction Program 21B04**

Certain 2017 through 2020 Model Year F550 Equipped with Payload Plus Upgrade Package  
Frame Rail Crack

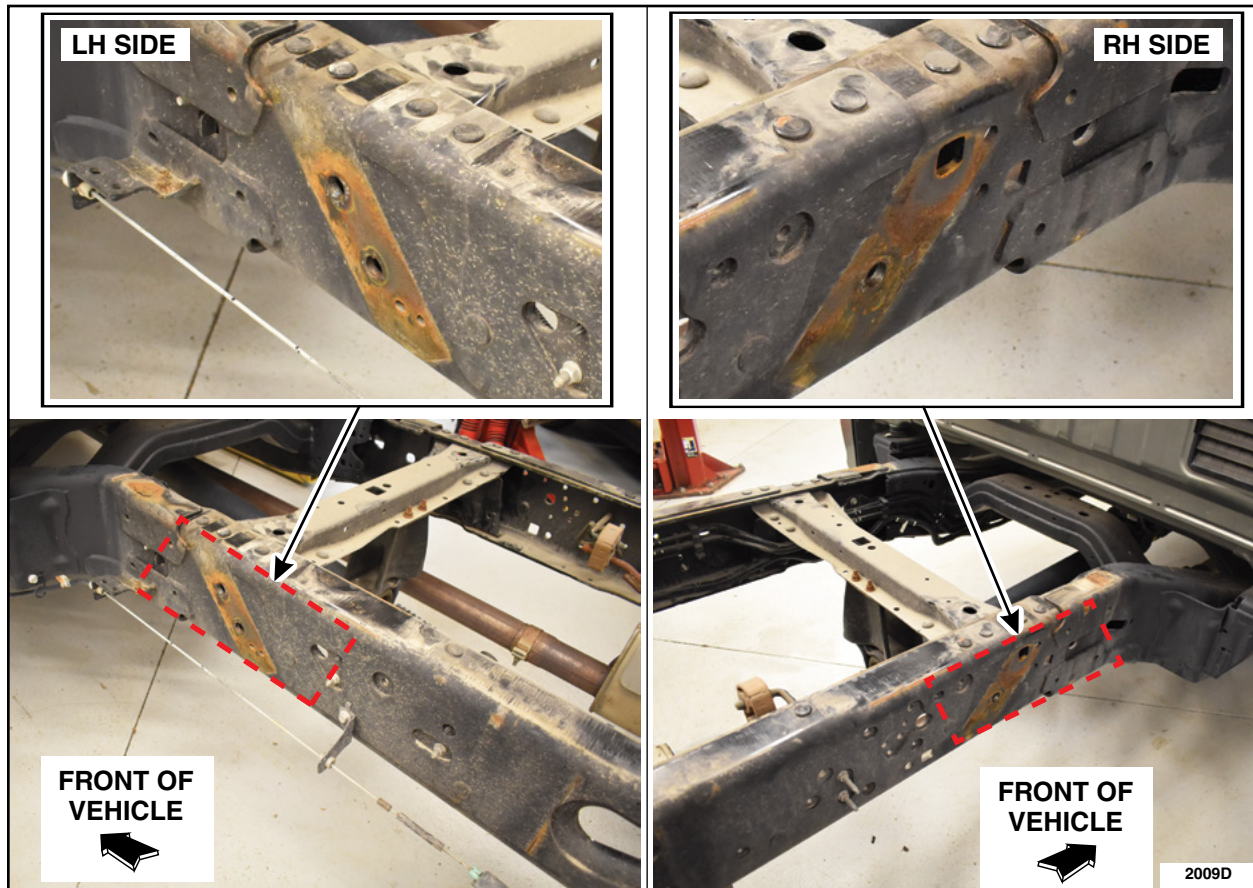
FIGURE 1

In some of the affected vehicles certain second unit body (SUB) upfits could cause stress points on the frame rail. Over time this stress could cause a crack in the frame rail behind the cab.

1. Identify and inspect the areas where the frame rail may exhibit signs of stress or a crack. Using compressed air, clear any debris that may be on the frame rails in the area of red dashed box. See Figure 1.

- Are there any signs of stress or cracks found on the frame rail?
  - Yes - Contact Special Service Support Center (SSSC).
  - No - Continue to procedure on Page 2.

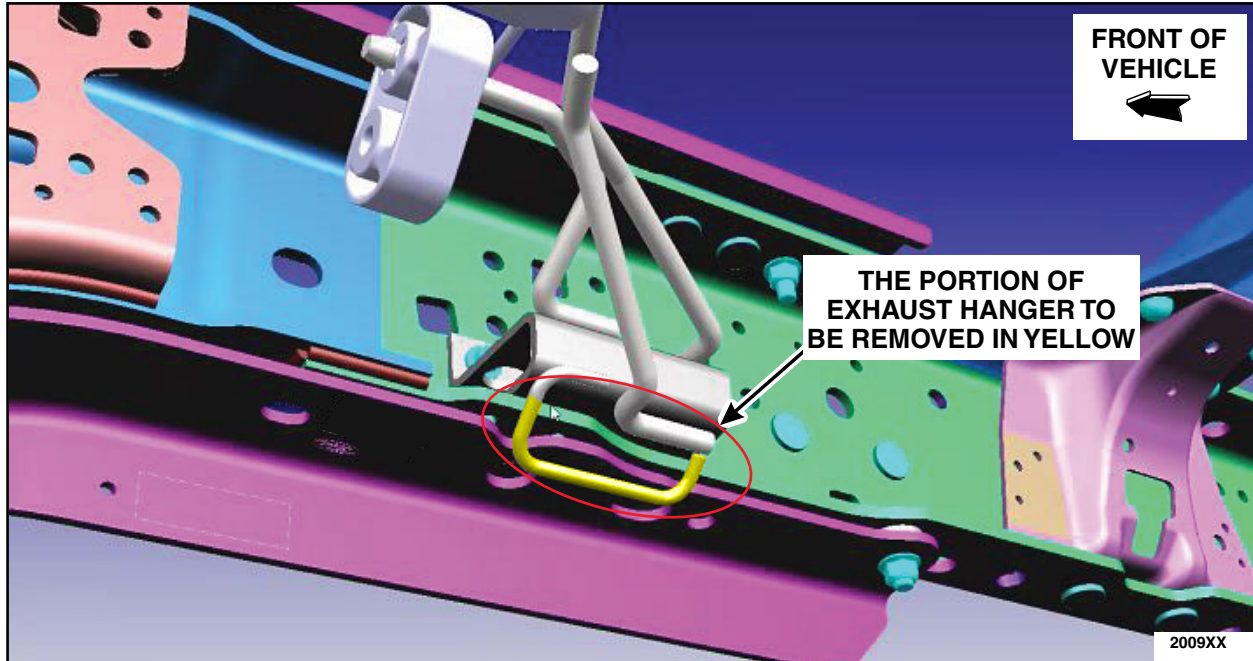
**FIGURE 43**

1. The right hand side exhaust hanger will interfere with right hand side lower reinforcement bracket.  
Figure 43 shows the portion of the exhaust hanger that will be removed in order to obtain the clearance needed.
