# TECH TIPS

**POPPING OR CRACKING NOISE THAT APPEARS TO BE COMING FROM THE MAST OR PEDESTAL AREA**

**NO. 148**

**MODEL(S):**  
OPTIMA HR  
OPTIMA HRX  
OPTIMA TC  
OPTIMA TCX

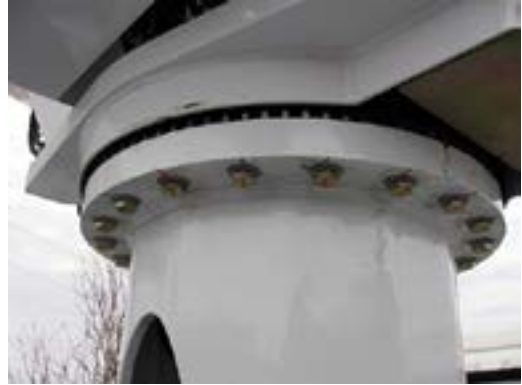
**FIGURE 1**

When the noise is duplicated, have someone listen near the joint of the rotation bearing to the pedestal and the pedestal to the subframe (**Figure 1 and 2**). The noise should be loud at one or both locations and will present as a cracking or popping sound.
