# TECH TIPS

LOSS OF COMMUNICATION BETWEEN THE TRANSMITTER AND RECEIVER

NO. 68

**MODEL(S):**  
TL171  
SWING ARM RADIO SYSTEM -  
H71-000011

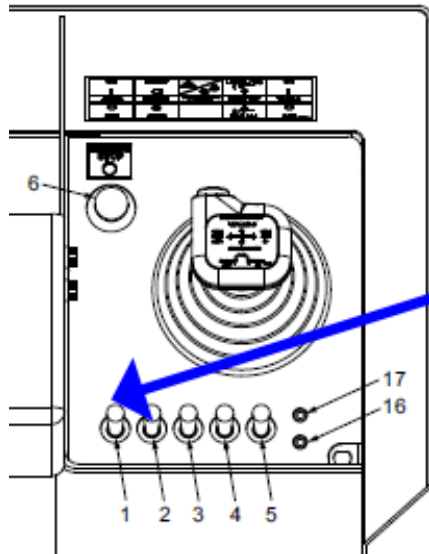
## STEP 1

Turn off the transmitter power switch #1 for three seconds.

Turn on transmitter power switch #1 and verify that LED #16 is ON.

If LED #16 is OFF, check to see if the radio has been set to lower controls instead of upper controls. If not, set to upper controls and repeat.

After 3 to 6 seconds, LED #17 should start to blink. If not, repeat Steps 1 thru 3. The transmitter has six possible channels for communication with the receiver. A new channel is selected each time Steps 1-3 are completed until one is found that provides a clear signal with no interference.

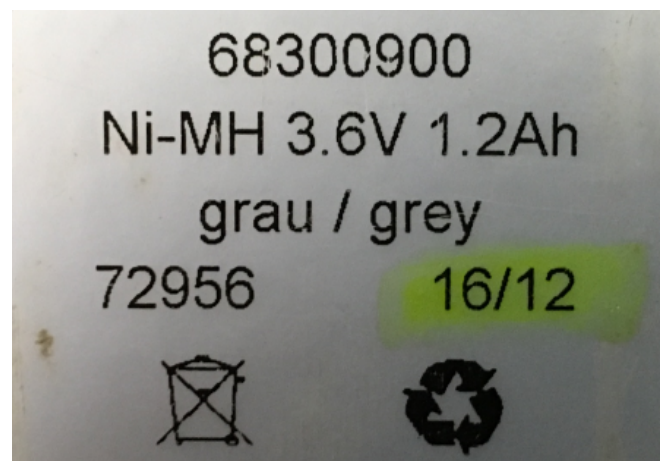
The first set of two numbers indicates the week that the battery was manufactured. The second set of numbers is the year the batteries were manufactured.

In the example below, the batteries were manufactured in the 16th week of 2012.
