TECH TIPS

RELIEF VALVE EROSION

NO. 72

MODEL(S):
ALL TEREX UTILITIES DIGGER
DERRICKS EQUIPPED WITH
DIGGER RELIEF MANIFOLD BLOCK

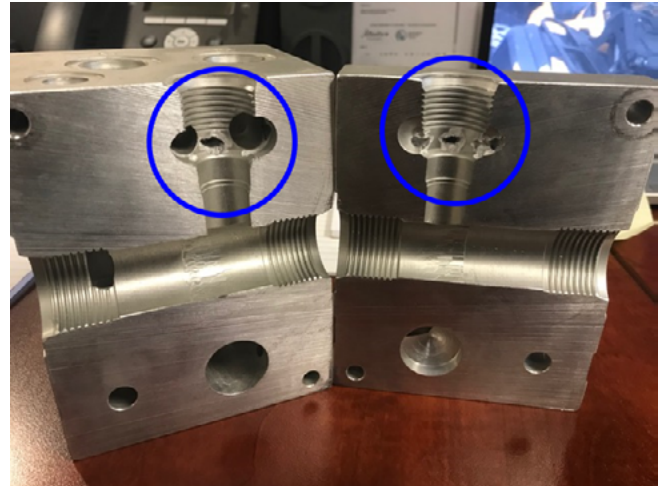
Under certain conditions, the digger derrick relief manifold block may develop a pinhole leak near the main system relief. The pinhole leak is caused by erosion of the relief return cavity, which will then wear away the material surrounding the return port until it reaches the outside of the manifold.

The photo below shows a cutaway of a manifold with the erosion in the return port of the relief valve cavity circled for clarity.

If signs of erosion are found, replace both the manifold and the system relief valve.

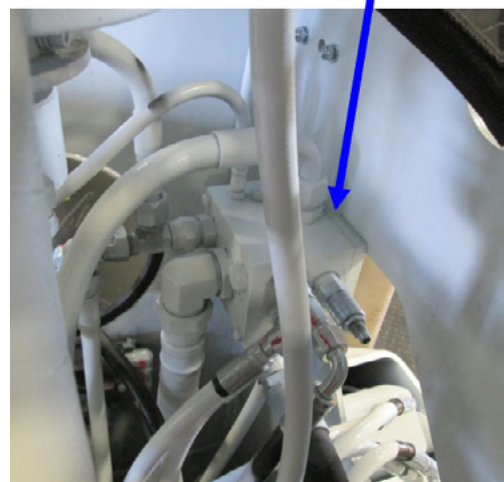
**Mounting Plate
and Manifold**

Verify that the hydraulic leak is coming from the relief manifold block. Hydraulic oil will be leaking from between the mounting plate and the manifold.

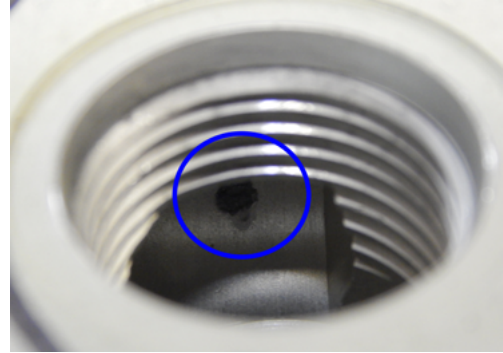
Remove the system relief and inspect the cavity for erosion in the return porting.
