TECH TIPS

INSPECTING FIBERGLASS LEVELING RODS

NO. 55

TECH TIP 55 | RELEASED 07.27.2022 | VERSION 1.0
©TEREX UTILITIES. ALL RIGHTS RESERVED

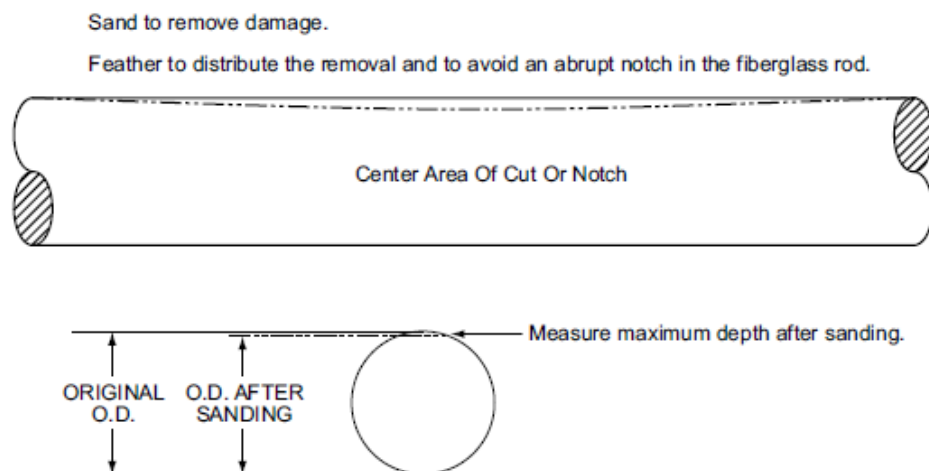
FIGURE 1

After sanding the damaged area, use the chart in the unit specific maintenance manual to determine the depth of the damage. If the damage exceeds the maximum allowed, replace the rod. **Figure 1**

Rod Diameter	Max Depth
.50	.125
.75	.156
.88	.172

If any damage is found, sand the rod to remove the damage. Feather the area to distribute the removal of the damage, avoiding an abrupt notch in the rod. (See diagram below)

If the rod does not require replacement, seal the area with a marine type gel coat to prevent moisture and contamination from seeping into the rod. Evercoat Gel Coat Scratch Patch is just one example that may be used.

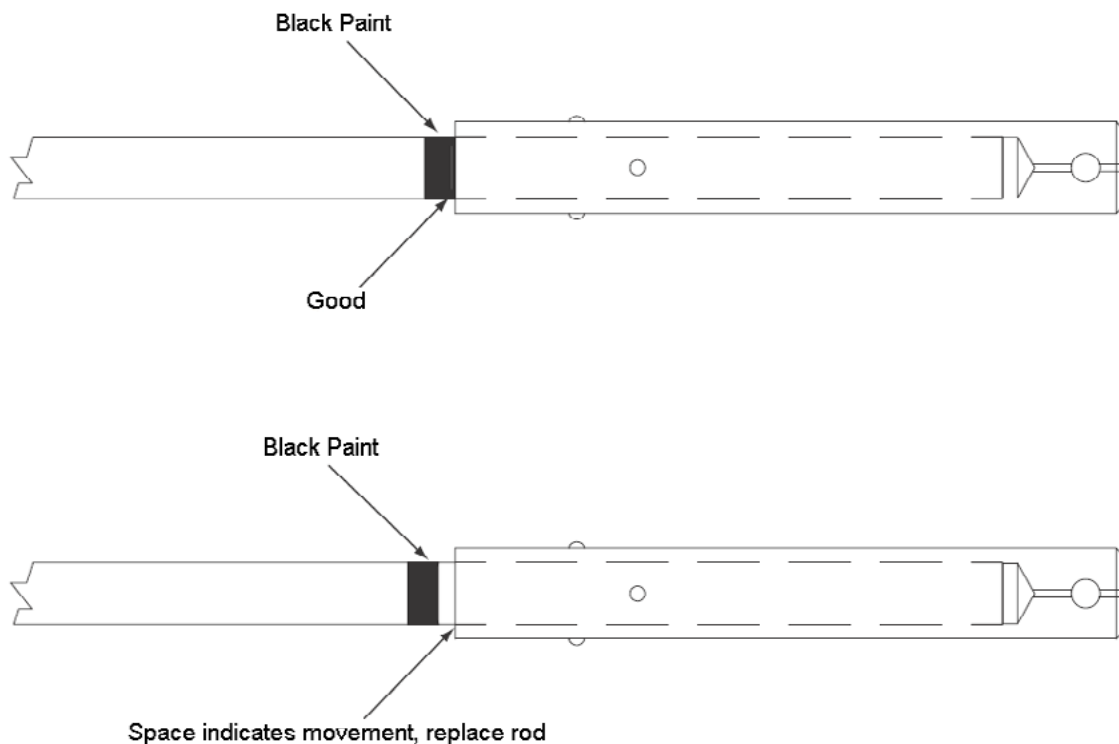
FIGURE 2

Check the terminal end and inspect the area bonded on the ends. The smaller ½" rods with the roll pins on the ends will have a black paint mark against the terminal end.

If there is no gap between the terminal end and the black paint marker and the roll pins are in place and have not sheared, then the rods may be placed back in service. This style of rod is common in the XT series. **Figure 2**

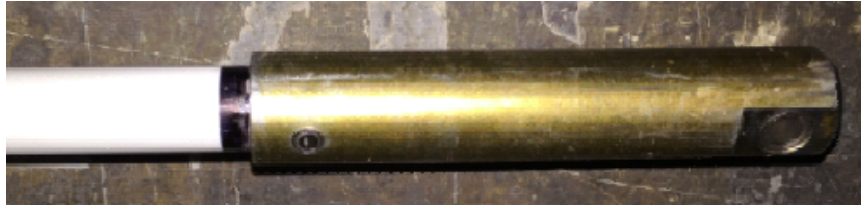
These are examples of the latest rods found in the XT Pro series. Note that they are in good condition and have not separated from the terminal end.

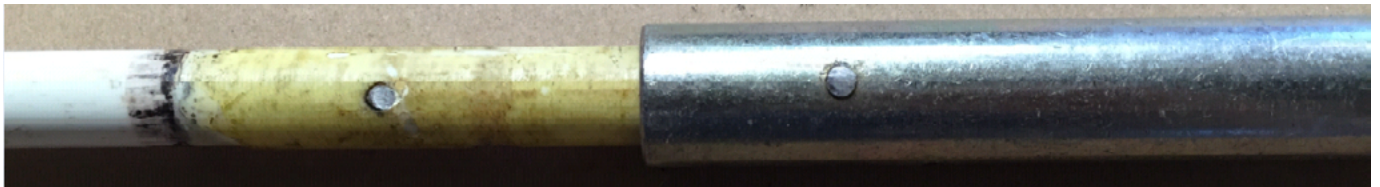
Below is an example of the smaller leveling rod terminal ends. This is an example of a failure. Notice it pulled away from the marker and the pins are sheared.

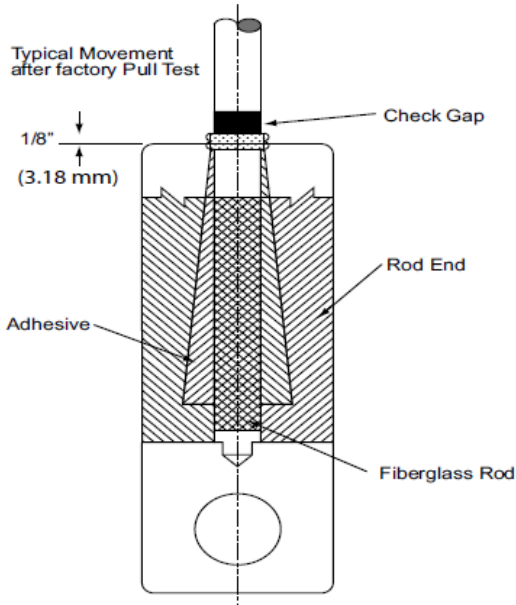
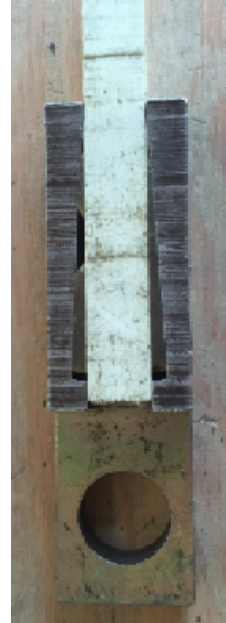
Units equipped with platform rotation have a wedge-shaped cavity. Each rod is pull tested after curing and will typically move 1/8". If the gap between the O-ring and the terminal is larger than 1/8", then further evaluation is needed to determine if the rod must be replaced.

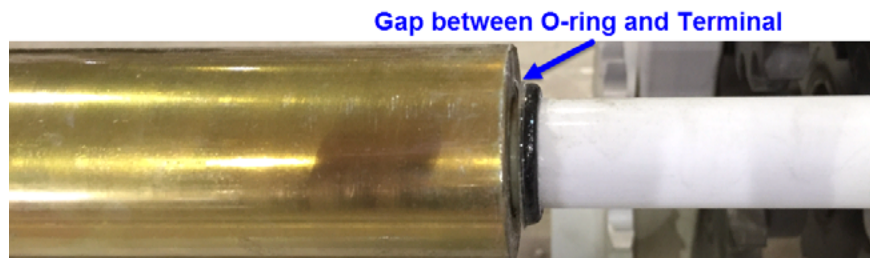
The picture above is an example of what the terminal end looks like on the heavy leveling rods found on any unit with platform rotate produced on or before November 2016.

Examples include: HR, HRX, TC, TCX, OM, RM, RMX, SC, and SCM models.

On these style leveling rods, a 1/8 inch gap is normal between the O-ring and the terminal end. If a gap is larger than 1/8", further evaluation is needed to determine if the rod must be replaced.

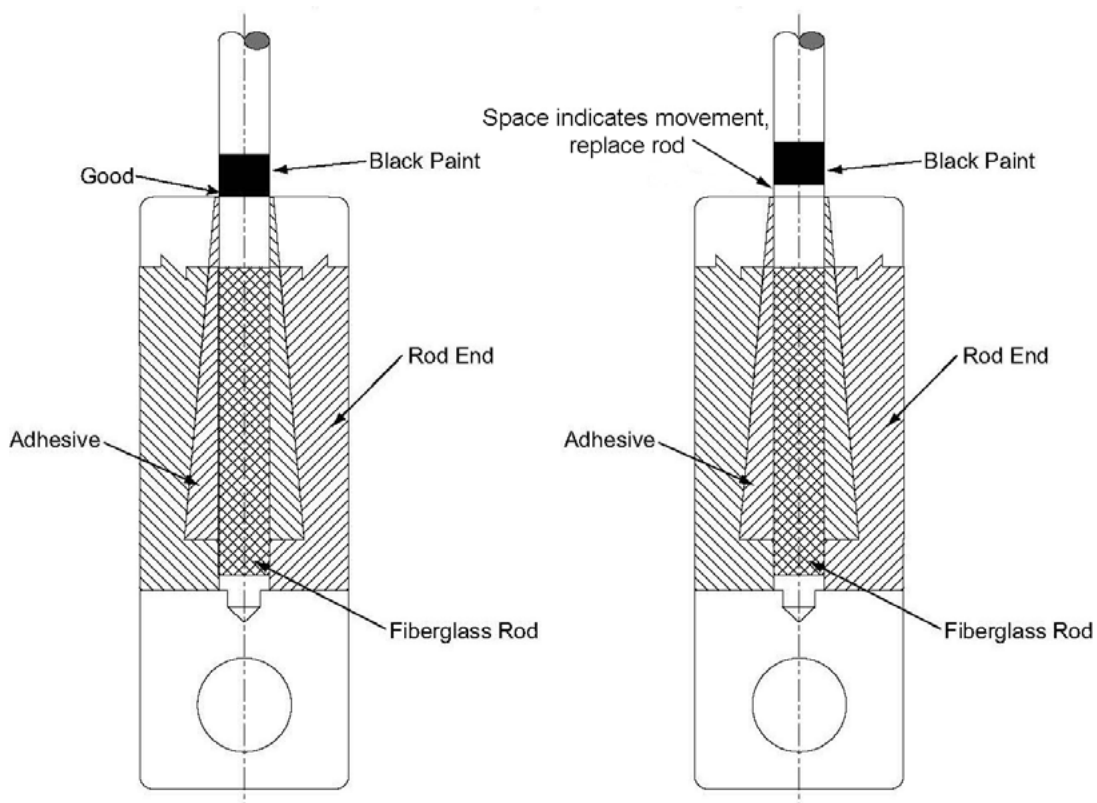
Note: Starting in November of 2016, a change has been made to the visual aid for detecting movement in the leveling rod assembly between the insulated rod and rod end. The O-ring has been replaced by a black paint mark at the terminal that is applied after the pull test.

If there is no gap between the terminal end and the marker, then the rods may be placed back in service. If a gap exists, the rod must be replaced.
