<b>Terex Utilities</b>	
<b>PRODUCT ADVISORY</b>	<b>PA705</b>

**SUBJECT:** 2017 – 2020 Model Year Ford F550 Frame Reinforcement

**SUBJECT: Customer Satisfaction Program 21B04**

Certain 2017 through 2020 Model Year F550 Equipped with Payload Plus Upgrade Package  
Frame Rail Crack

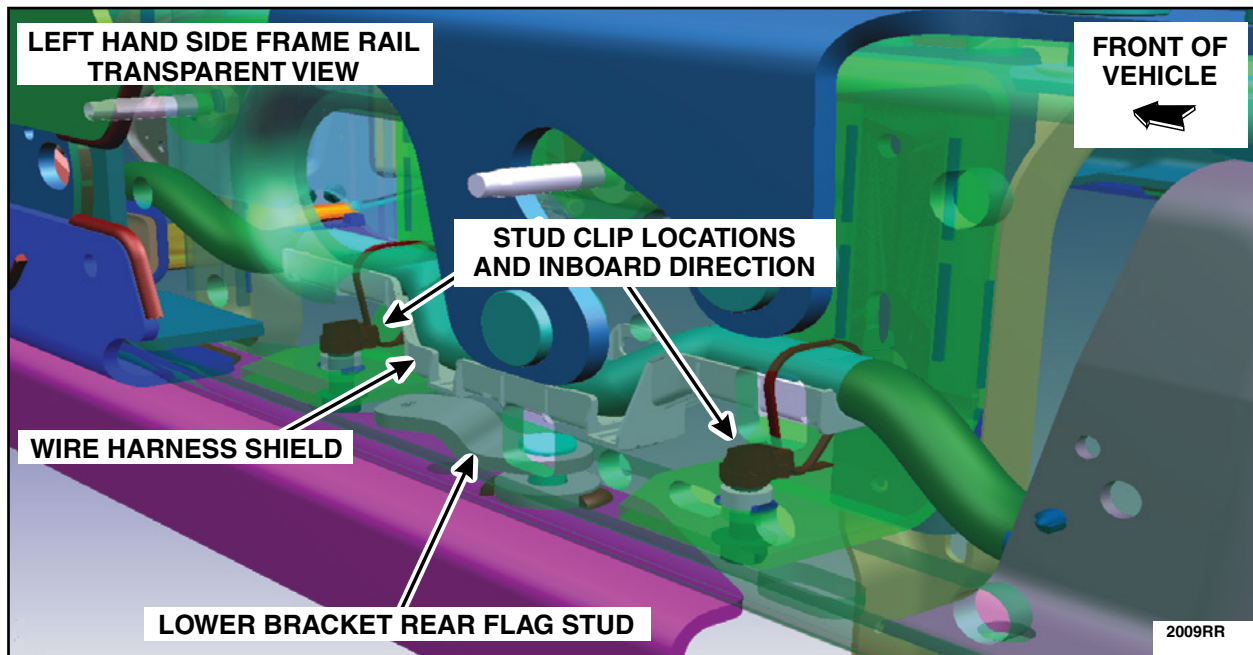
**FIGURE 37**

1. For the left hand side lower frame rail bracket, the rear flag stud will contact the harness shield if not raised. Raise the harness by completing the follow steps;

- Position the supplied stud clips onto the studs with the zip ties side facing inboard as shown in Figure 37.
- Secure the harness to the stud clips with the zip ties.
- Ensure that the harness shield is positioned above the flag stud and the stud clips are fully seated on the studs.
