TECH TIPS

RELIEF VALVE EROSION

NO. 72

MODEL(S):
ALL TEREX UTILITIES DIGGER
DERRICKS EQUIPPED WITH
DIGGER RELIEF MANIFOLD BLOCK

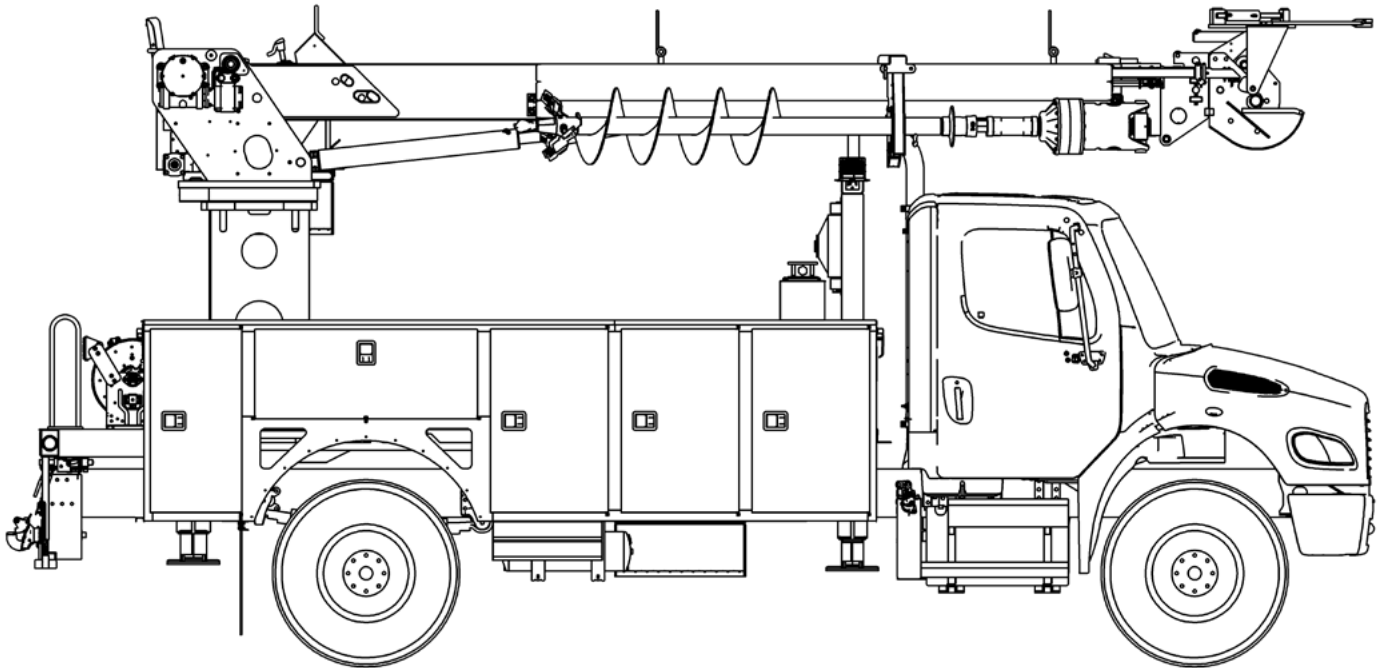
| *Clean area and verify leak location*

Under certain conditions, the digger derrick relief manifold block may develop a pinhole leak near the main system relief. The pinhole leak is caused by erosion of the relief return cavity, which will then wear away the material surrounding the return port until it reaches the outside of the manifold.

Verify that the hydraulic leak is coming from the relief manifold block. Hydraulic oil will be leaking from between the mounting plate and the manifold.

If signs of erosion are found, replace both the manifold and the system relief valve.
