**Terex Utilities****PRODUCT ADVISORY****PA680****DATE:** 3/3/2020**REVISED:****TO:** Owners, Users, Dealers, and Installers**MODELS AFFECTED:** Optima Aerial Device**SUBJECT:** Lower Boom Angle Indicator**Issue:**

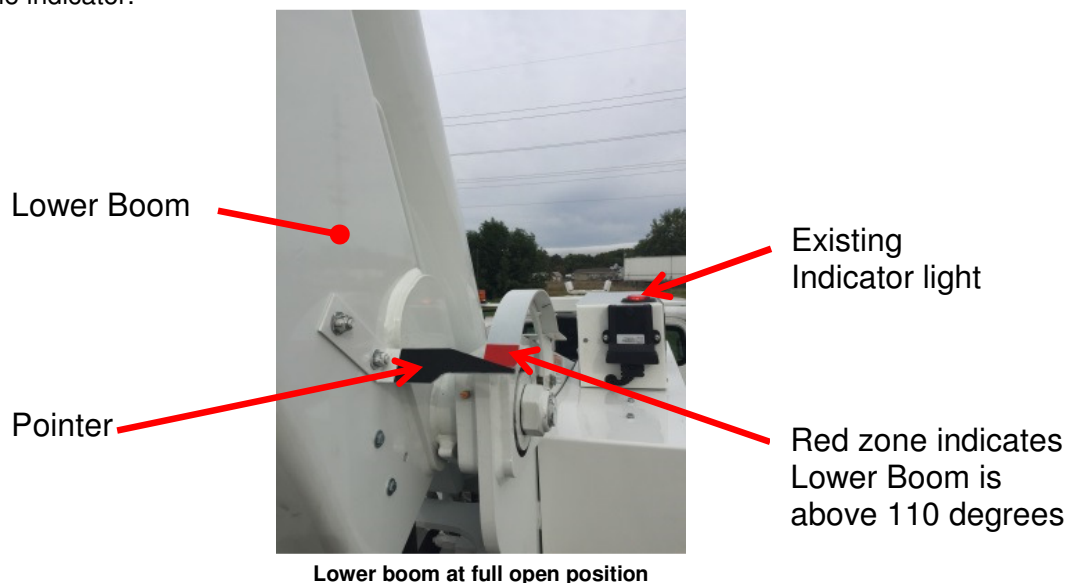
Terex is offering Field Service Kit Z1545 for units in the field should the customer be interested in purchasing an added angle indicator for an existing Optima unit built prior to October 2019. See figure identifying location of the lower boom angle indicator.

Terex Optima Series Aerial devices have dual zoned load charts with different capacities when the lower boom travels past 110 degrees. The unit is equipped with a visual indicator light which comes on when the lower boom travels past 110 degrees to alert operators of the different capacities. Terex is offering a lower boom angle indicator to provide the operator visibility prior to approaching 110 degrees.
